Transportation Safety Board
of Canada

TRANSPORTATION SAFETY

Issue 20 – Winter 2004

**Derailments, collisions
and dangerous goods**

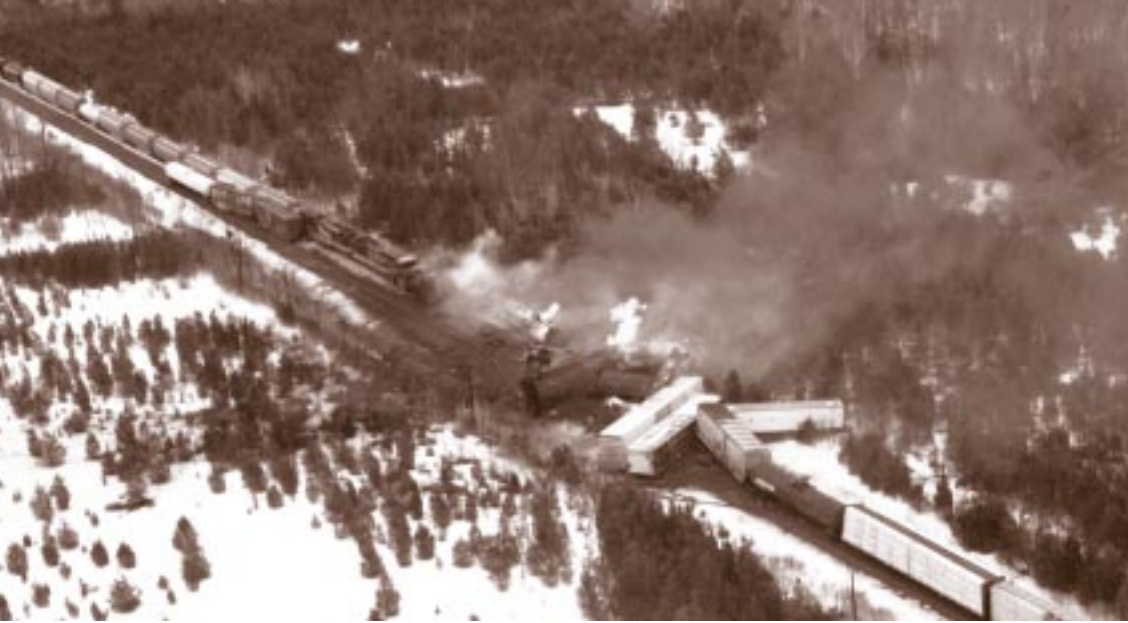
Aerial view of accident site on the day of occurrence

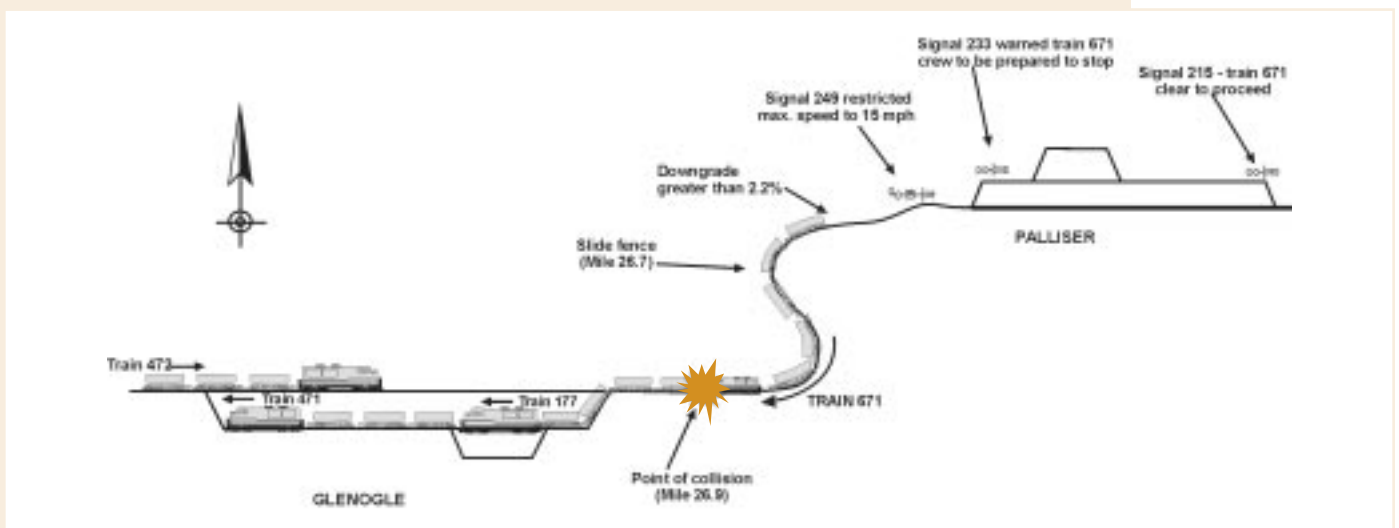
Train 671, en route from Field, British Columbia, passed Signal 215 at the east switch at Palliser, British Columbia, which displayed a “Clear” signal indication. A few minutes later, the train encountered a “Clear to Stop” signal indication at Signal 233, located at the west switch at Palliser. A “Restricting” signal indication was displayed at Signal 249. The train’s speed was reduced to 17 mph in advance of a slide detector fence at Mile 26.7, the train crew assuming that the “Restricting” signal indication was displayed as a result of a rock fall or slide.

Sketch showing position of trains and signals
